NASA TECHNICAL MEMORANDUM

NASA TM X-58141
June 1974

FULL-SCALE AIRCRAFT CABIN FLAMMABILITY TESTS
OF IMPROVED FIRE-RESISTANT MATERIALS

Robert N. Stuckey, Daniel E. Supkis, and L. James Price
Lyndon B. Johnson Space Center
Houston, Texas 77058

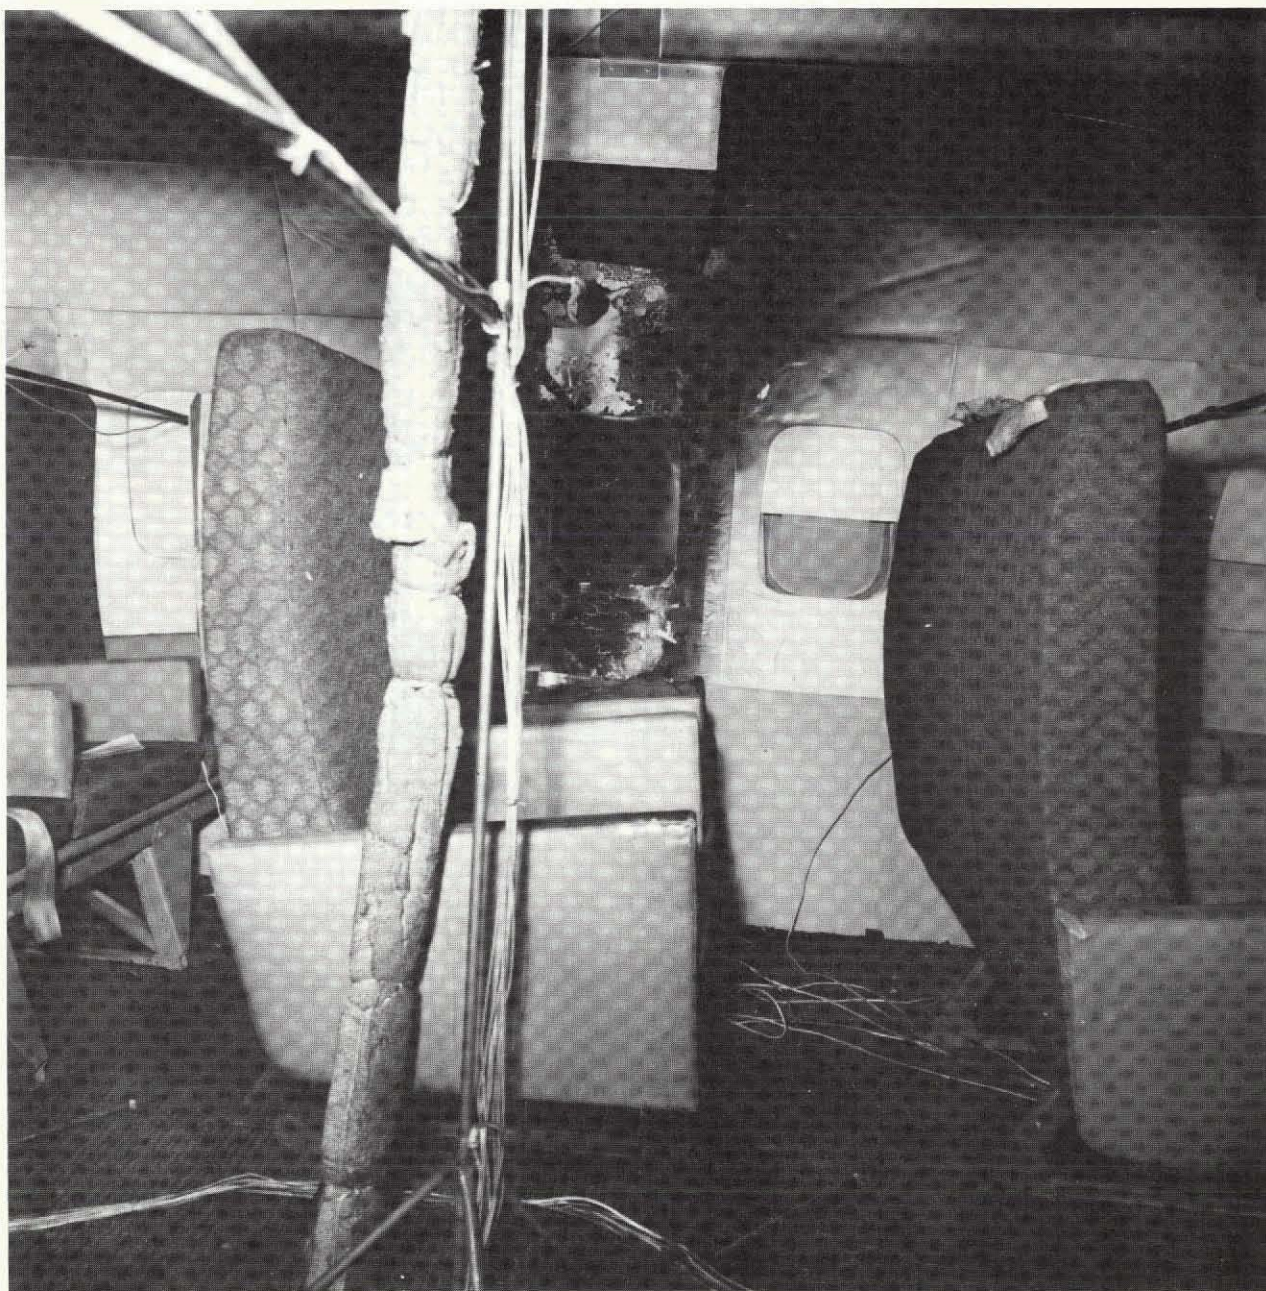
Figure 20.- Fire damage for test 2 using new materials, side view.

Figures 20 to 24 show clearly that flames did not propagate, and damage was confined to the seat above the fire and the adjacent sidewall. The ceiling was severely damaged (fig. 21), but, because of inadequate insulation behind panels adjacent to the ignition source, flames melted through the sidewall and spread between the sidewall and insulation to the unprotected back side of the ceiling panels, which had a flammable paper honeycomb core. The flames then melted through the aluminum skin above the ceiling panels, and the test was terminated after 280 seconds to prevent destruction of the fuselage. The paper honeycomb ceiling panels were not intended for involvement in the fire since they were known to be flammable and are to be evaluated in subsequent tests using fire-resistant materials.

2. Sidewall: A 61-centimeter (2 foot) wide section of the sidewall covering (Kel-F and Fluorel on Durette) adjacent to the fuel pan was charred from the floor to the hatrack, and the aluminum panels were partly melted. The sidewall extending outward from each side of the charred area was scorched and blistered (fig. 20).

Comparison with other tests.- Far less material damage occurred in test 2 than in test 1, and propagation of the fire was limited (figs. 15 and 20). A comparison of ceiling temperatures (fig. 25) indicated a maximum temperature of 505 K (450° F) for test 2, whereas, during test 1, the

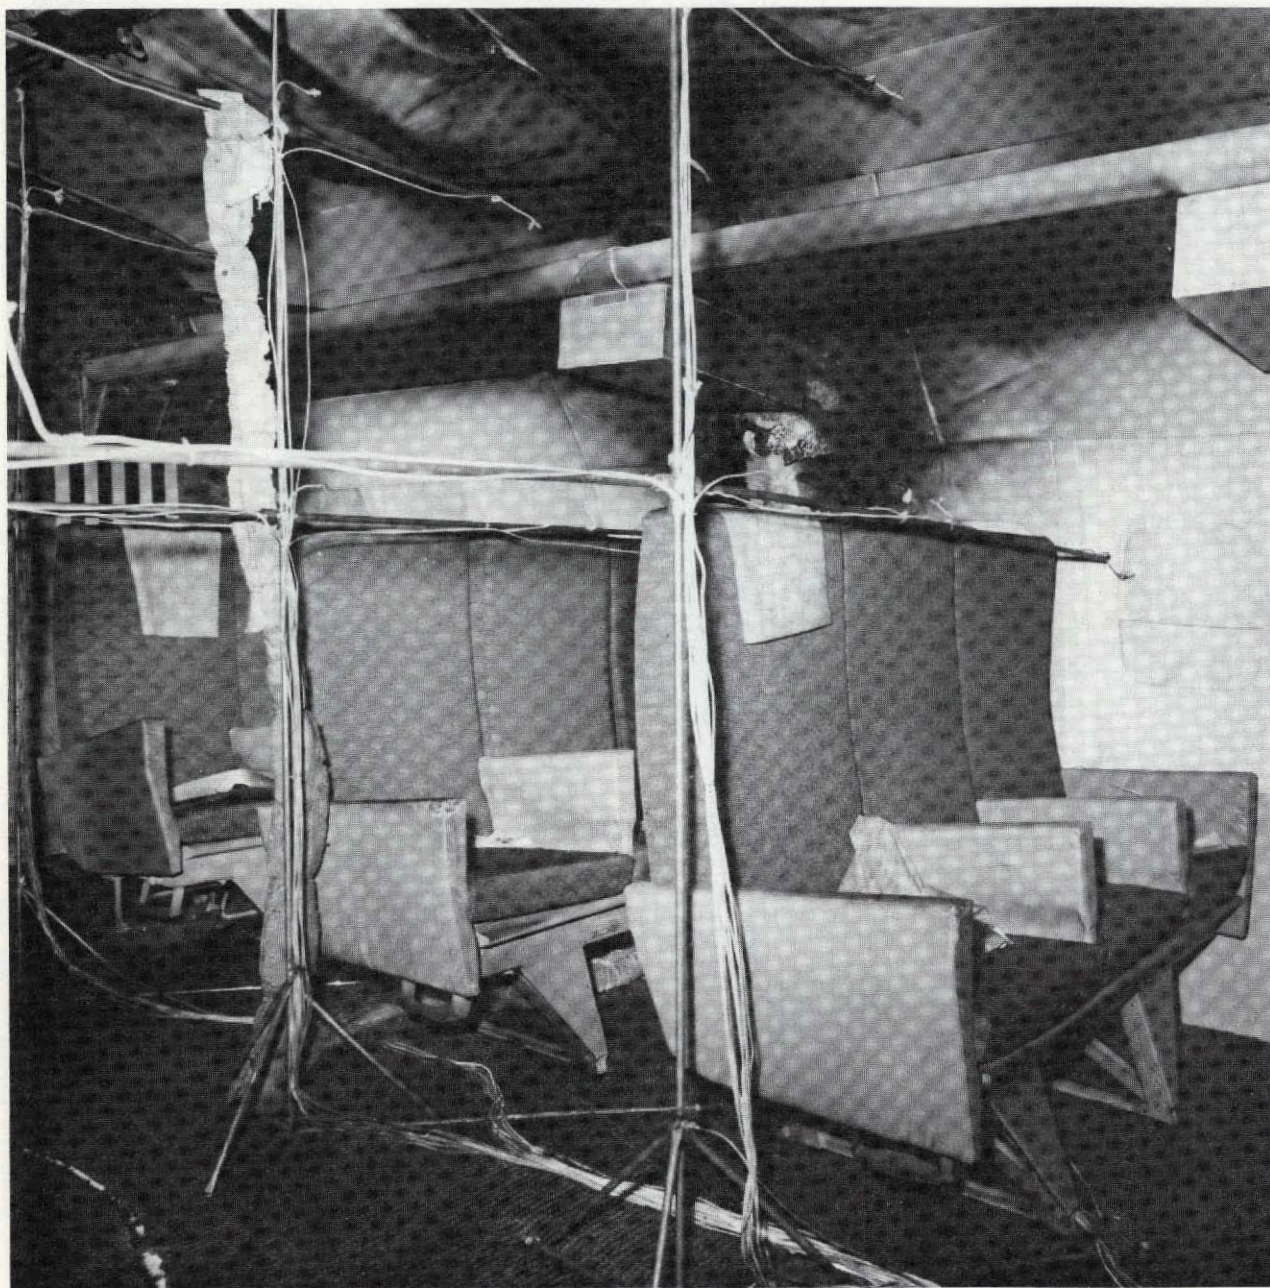
Figure 21.- Fire damage for test 2 using new materials, front view.

4. Ceiling panels: The ceiling panels were heavily charred where they joined at the middle of the test section (fig. 21). Close examination revealed that the panels had burned from the back side, which had not been covered with the fiberglass cloth overcoated with Kel-F and Fluorel. (The same type of ceiling panel used in test 1 was covered on one side only with the Kel-F/Fluorel/fiberglass-cloth composite for use in test 2.) The back side had been ignited by flames that melted the sidewall and spread between the sidewall and insulation up to the back side of the ceiling panels. The remaining interior side of the ceiling was slightly scorched.

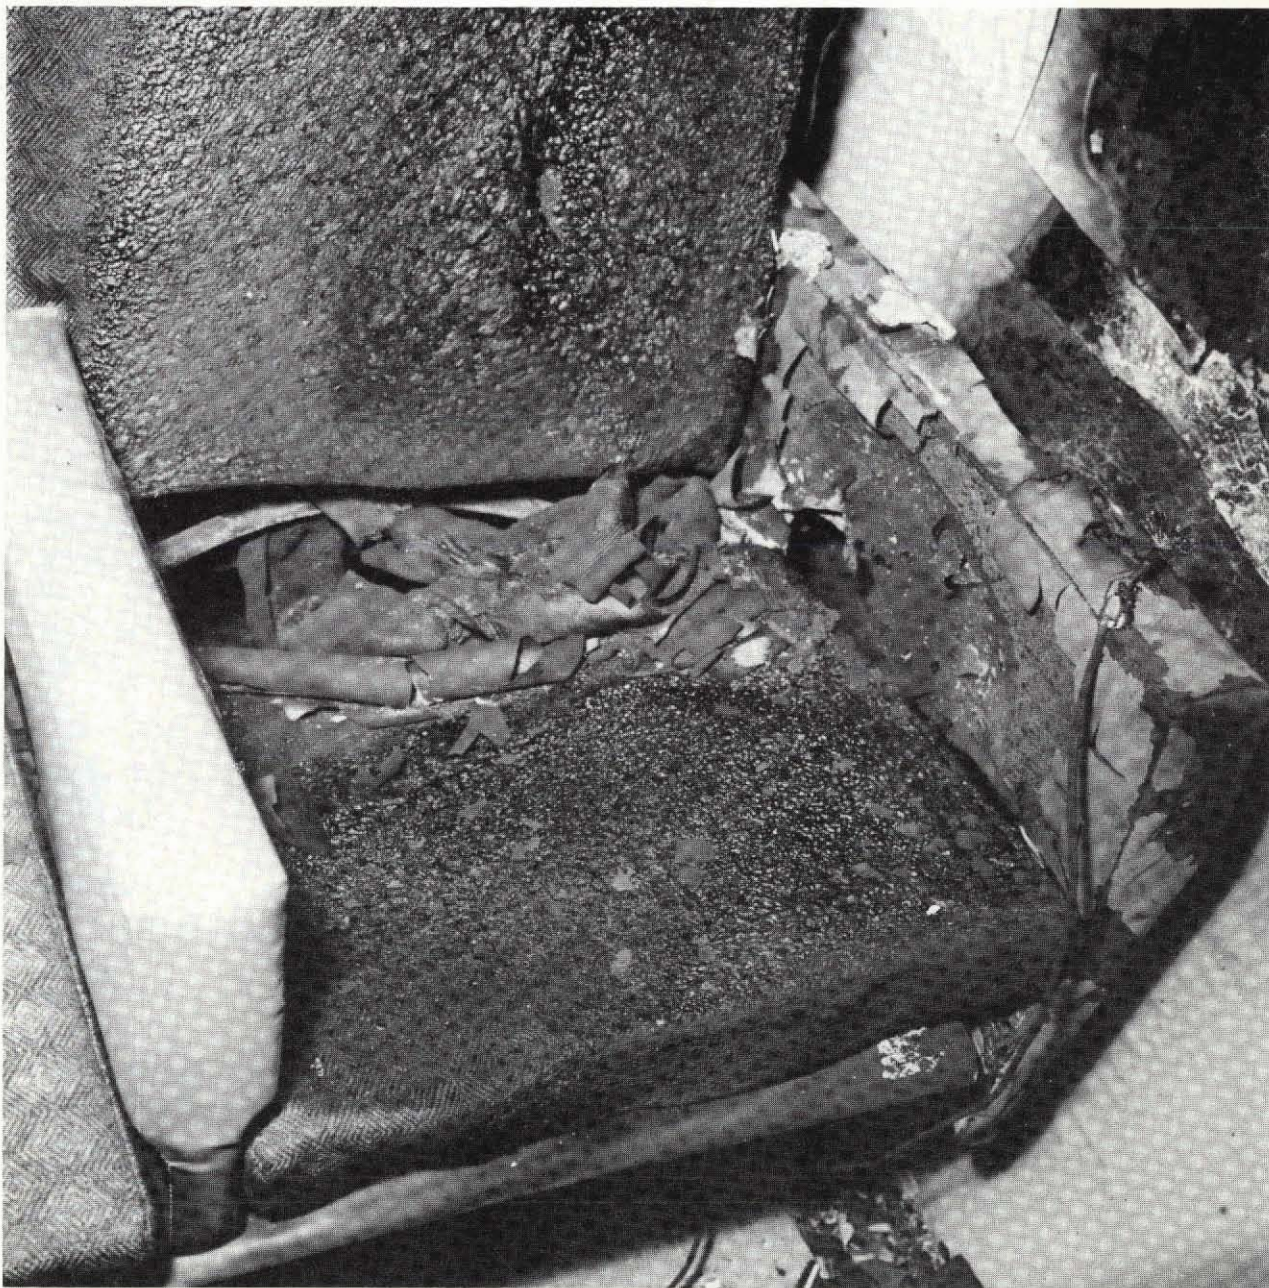
Figure 22.- Seat bottom fire damage for test 2 using new materials.

1. Seats: The seat above the fire was partly consumed by the fire, and some of the metal structure had melted away

(figs. 22 to 24). Approximately 95 percent of the bottom seat cushion upholstery was charred, and approximately 50 percent of the fire-retardant foam padding was consumed. The front of the seat-back upholstery was 70 percent charred, the back side was 25 percent charred and 30 percent scorched, and the foam padding was damaged only slightly. The Nomex seatbelt was almost completely charred. The other seats were not damaged except for slight scorching of the seat adjacent to the damaged seat. Fire-resistant, disposable headrest napkins had also been included for evaluation; however, most of the napkins were blown from the seats when the carbon dioxide extinguisher was activated. The napkins that remained in place were not damaged.
